## CASE STUDY: University lighting system commissioned

Ohio Northern University's 105,000-square-foot, \$30 million, three-story James Lehr Kennedy Engineering Building was completed in fall 2019. The new facility in Ada, Ohio, allows more engineering student enrollment, increases laboratory space and encourages student-faculty collaboration. Student input resulted in an abundance of natural daylight in the new building. The facility has daylighting harvest sensors, vacancy sensors and high-efficacy LED lighting. The building is seeking U.S. Green Building Council LEED-NC v3 certification.

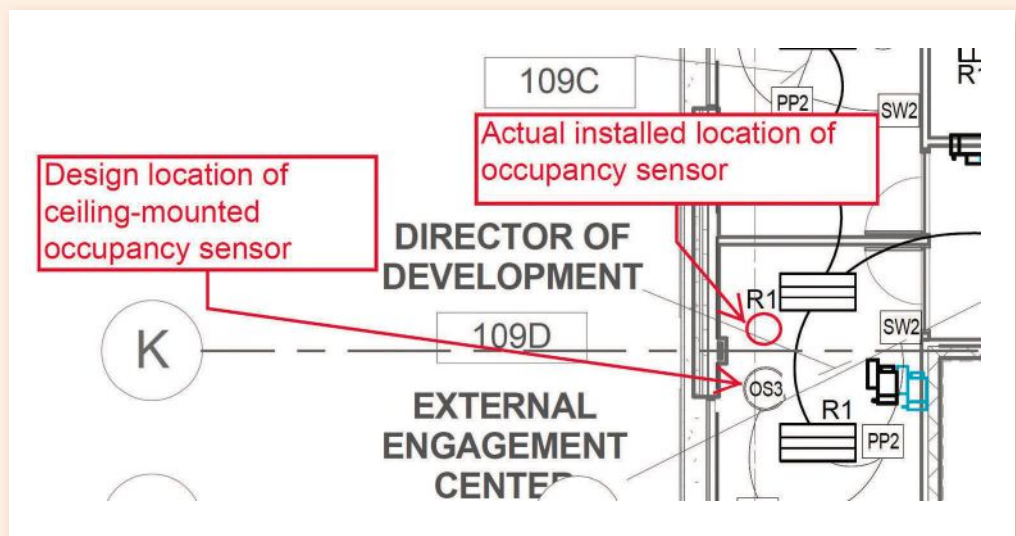
The commissioning authority found issues with some of the installed occupancy sensors. These ceiling-mounted sensors were not installed where there are shown on the construction drawings. This led to sensors not performing as designed and resulted in the room occupants "waving their arms" to keep the artificial lighting on.

Figure 4 shows a private office, Room 109D, with the ceiling-mounted occupancy sensor labeled "OS3" in the room. The sensor is placed too far away from the desk to detect minor motion such as the occupant using a computer while seated at her desk. The sensor also is placed too close

**Figure 4: A partial first-floor lighting plan showing the case study private office with design location of occupancy sensor and actual installed location of sensor. Courtesy: Metro CD Engineering**

to the door and can result in the lighting in her office to turn on when people walk past the door, but do not enter the office.

The incorrect location of the occupancy sensor has resulted in the lighting in the room to turn off while the occupant is completing tasks at her desk. The occupant has tried waving her arms, but the lighting remained off. The sensor's self-adapting technology usually recalibrates the sensitivity of the sensor when it detects someone waving their arms, but in this case, since her seated position was not within the sensor's minor movement coverage, the sensor could not keep the lights on.

The occupancy sensor is being relocated where shown on Figure 4 and this should fix the issue of the lights turning off when the occupant is working at her desk.
